## Case Study

### Sipetrol

### **Heat Shield™ OVER PLATFORM AM6 – SIPETROL – MAGHELLAN**

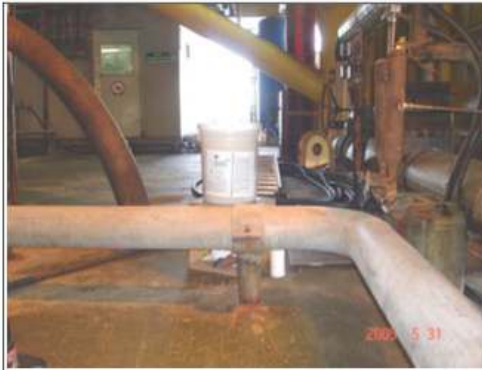
**View of the final section before the work**

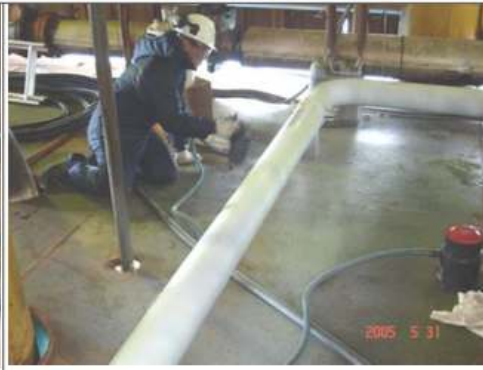
**Final section applying primer**

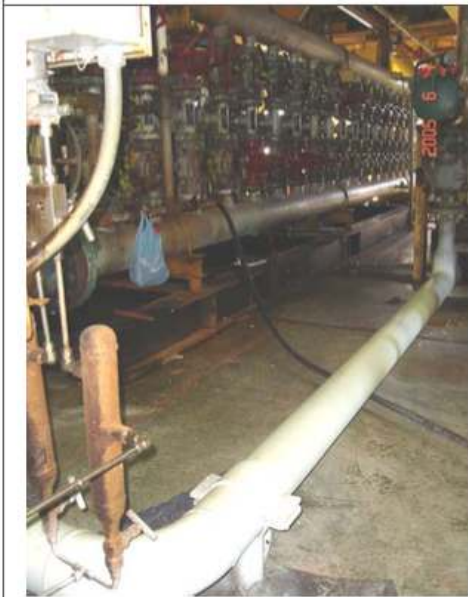
**Last trace of the pipeline before pumping.**

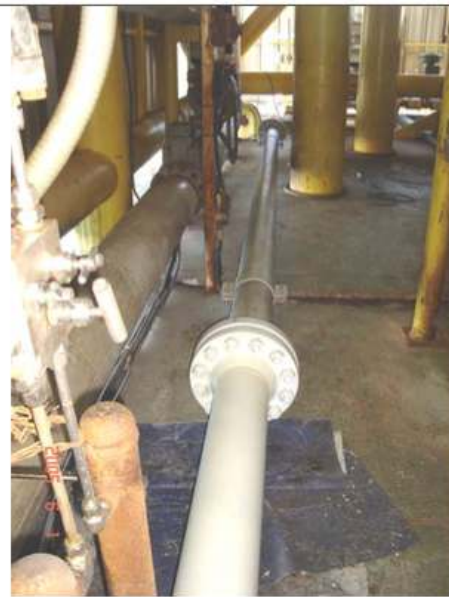
**Transition of the final section to the middle one with the work done**

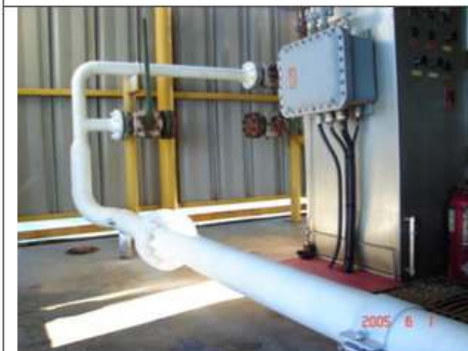
**First section. Work done**

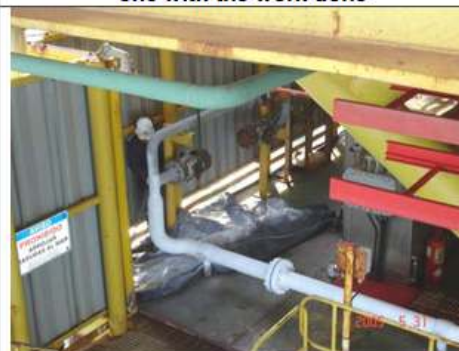
**First section during work.**

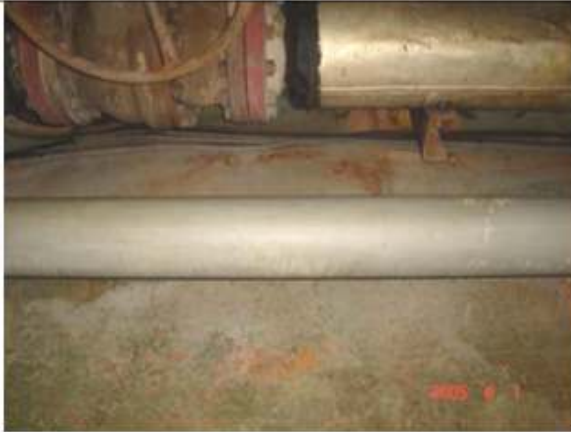
The central section, where primer was not applied, the average dry thickness of the film reached 300 to 350 microns (12 to 14 mils).

**Final aspect without primer. Middle section**

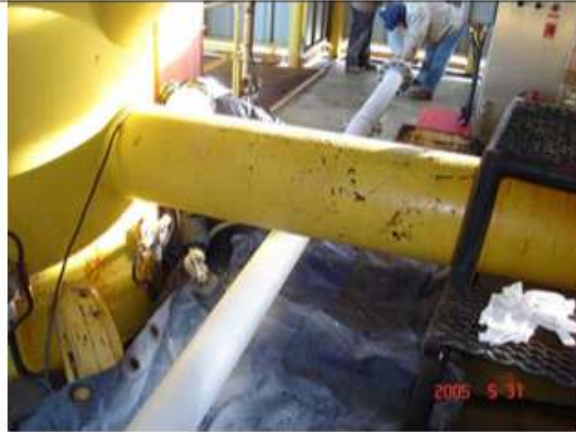
**Horizontal trace of first section at the beginning of work.**

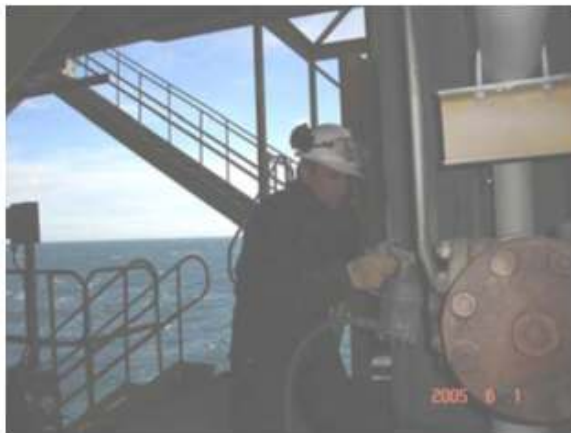
**First section at last coat. See environment.**
