Case Study

Metal Wall

Award Winning Energy Saving and Asset Protection Coatings

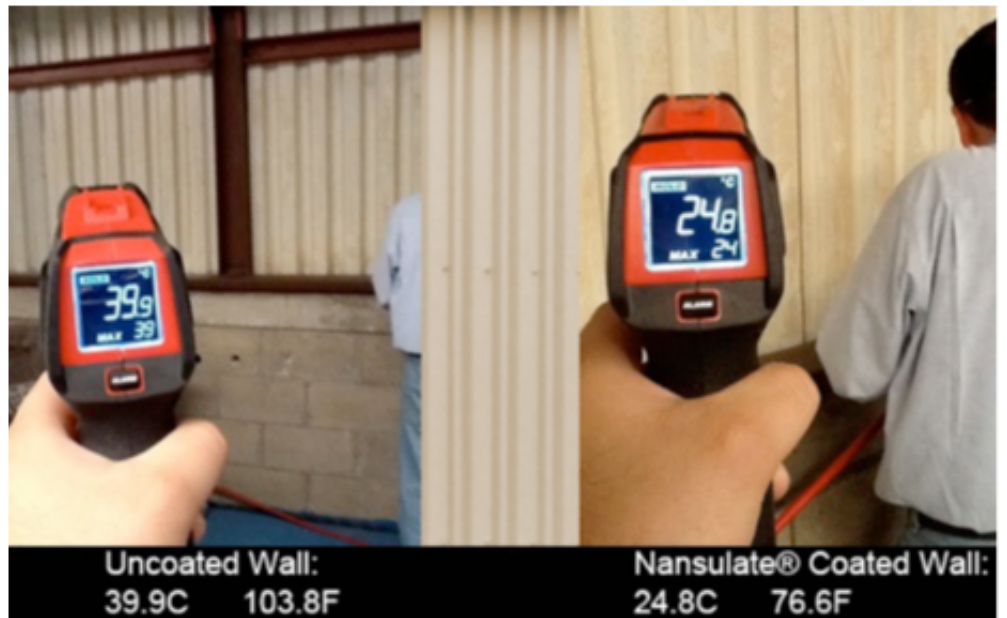
Synavax's™ Mexico Distributor, Omnigenus Energy, was assisting a large manufacturing client with an issue they were having with heat transferring through a large sheet metal wall that divides the main mezzanine from an area that holds six industrial ovens.

The heat transfer was causing uncomfortable working conditions. Heat Shield™ Translucent PT was applied at a 3-coat coverage to a 3x3 meter section of the wall to illustrate the insulation performance.

Even before the coating was fully cured measurements showed a reduction of wall surface temperature from 39.9C (103.8F) to 24.8C (76.6F).

A reduction of 15.1C /27.2F, with further reduction expected after the coating cures fully.

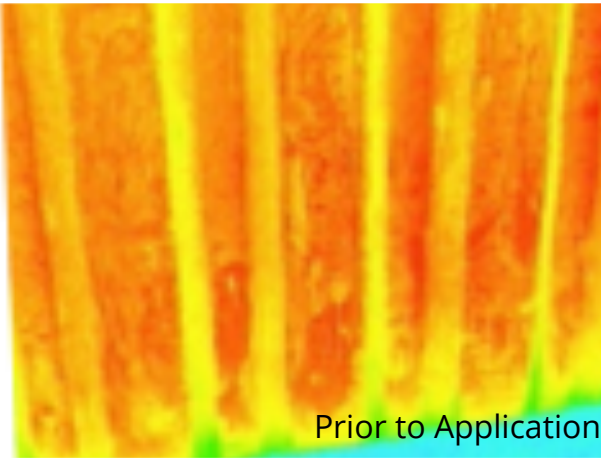
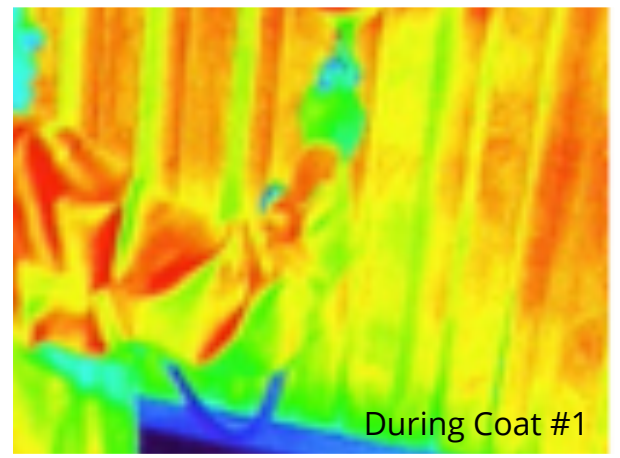
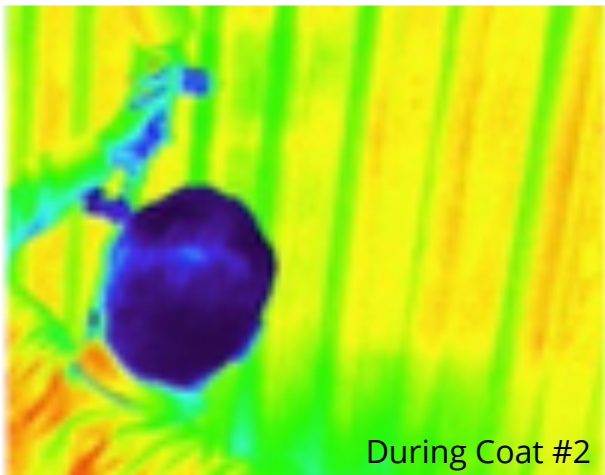
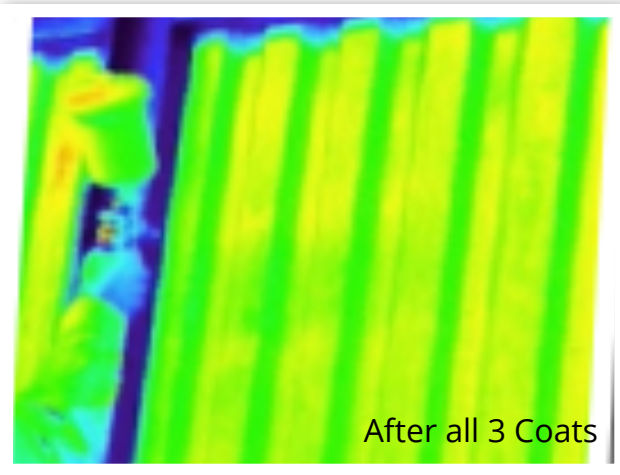
CASE STUDY
ADDITIONAL PHOTOS

Thermal imaging photos were also taken and clearly illustrate the reduction of heat transfer provided by the Heat Shield™ insulation coating technology.
