Case Study

Brunei Palace

Mold growth on the exterior marble Palace Walls was causing extensive maintenance costs to keep it clean.

Energy Protect™ thermal insulation & mold resistant coating.

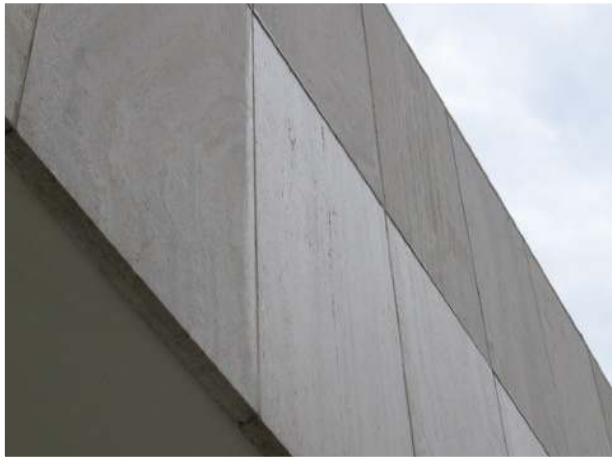
The entire wall was cleaned and the three lower tiles were coated with 2 coats of Energy Protect™ coating. After 1-year this photo was taken. The coated area was still free of any mold growth, while mold had returned as usual to the untreated marble areas.

The palace performed a year-long study of the Energy Protect™ coating for resistance to mold growth. Energy Protect™ was coated on the three lower tiles in the photo on the next page, and after a year proved to be resistant to mold growth in this extremely humid climate.

The tiles coated with Energy Protect™ remained free of mold growth, while the untreated tiles were once again covered with mold growth.

After the successful completion of the study, the Palace arranged for the application of 2-coats of Energy Protect™ for mold resistance to be applied to the extensive area of its marble palace walls.
