Case Study

Metal Wall

GEOGRAPHICAL AREA:
Mexico

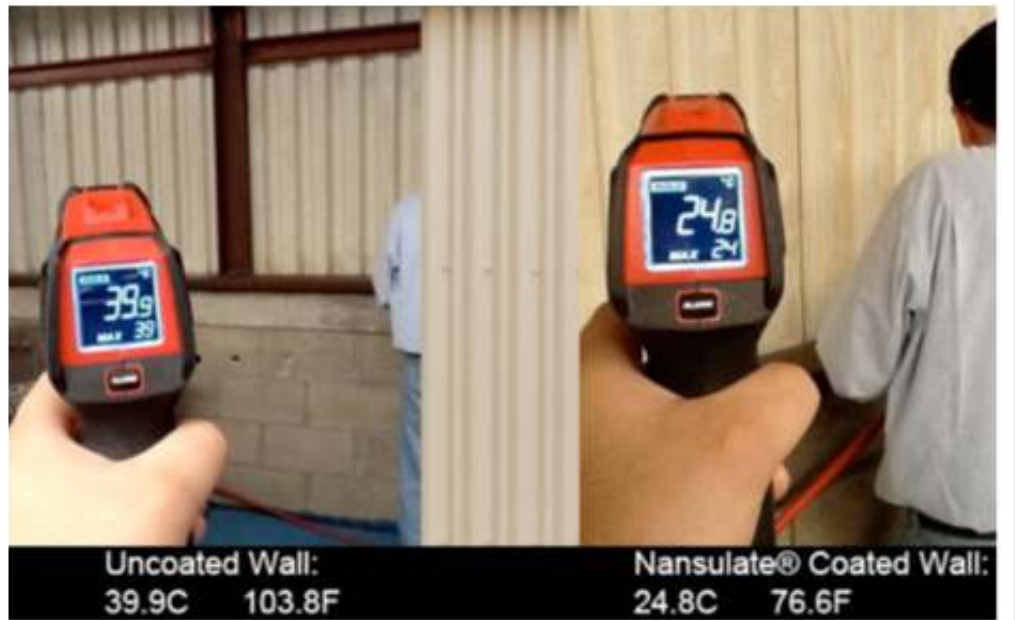
Syneffex's™ Mexico Distributor, Omnigenus Energy, was assisting a large manufacturing client with an issue they were having with heat transferring through a large sheet metal wall that divides the main mezzanine from an area that holds six industrial ovens.

The heat transfer was causing uncomfortable working conditions. Heat Shield™ Translucent PT was applied at a 3-coat coverage to a 3x3 meter section of the wall to illustrate the insulation performance.

Even before the coating was fully cured measurements showed a reduction of wall surface temperature from 39.9C (103.8F) to 24.8C (76.6F).

A reduction of 15.1C /27.2F, with further reduction expected after the coating cures fully.

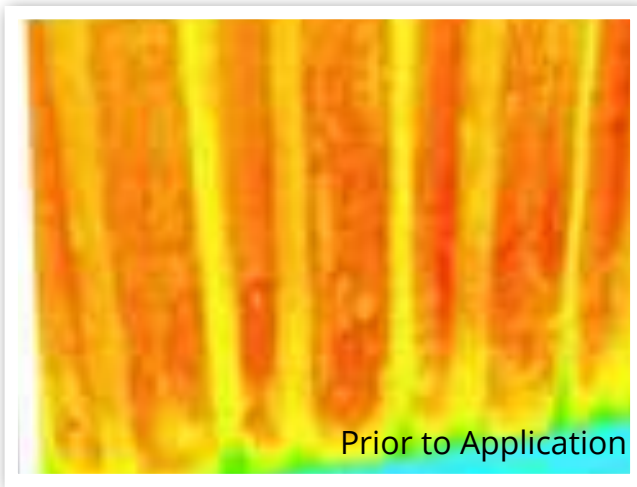
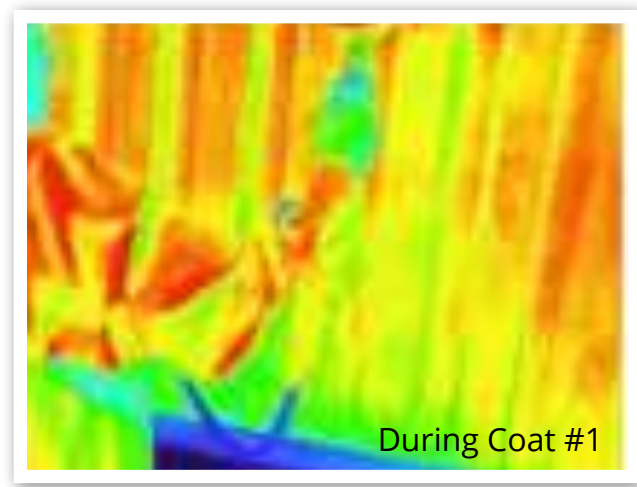
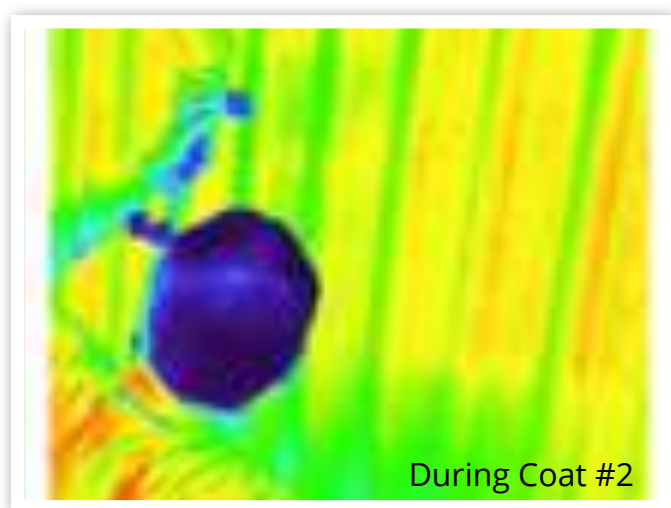
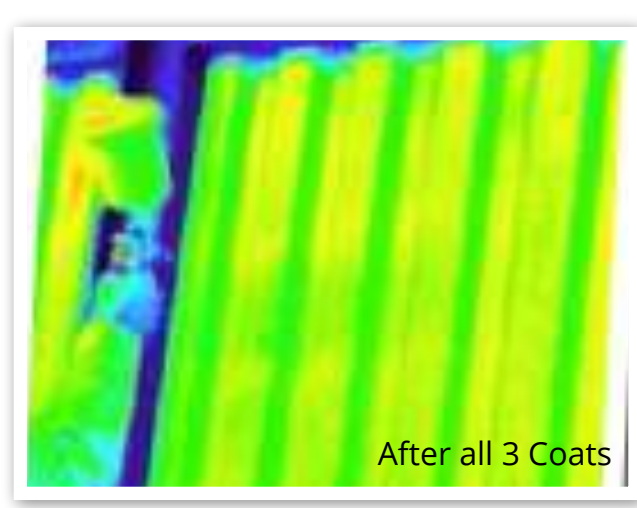
CASE STUDY
ADDITIONAL PHOTOS

Thermal imaging photos were also taken and clearly illustrate the reduction of heat transfer provided by the Heat Shield™ insulation coating technology.
