## Case Study Tire Manufacturer

Reduce heat to improve scanning ability of bar code label

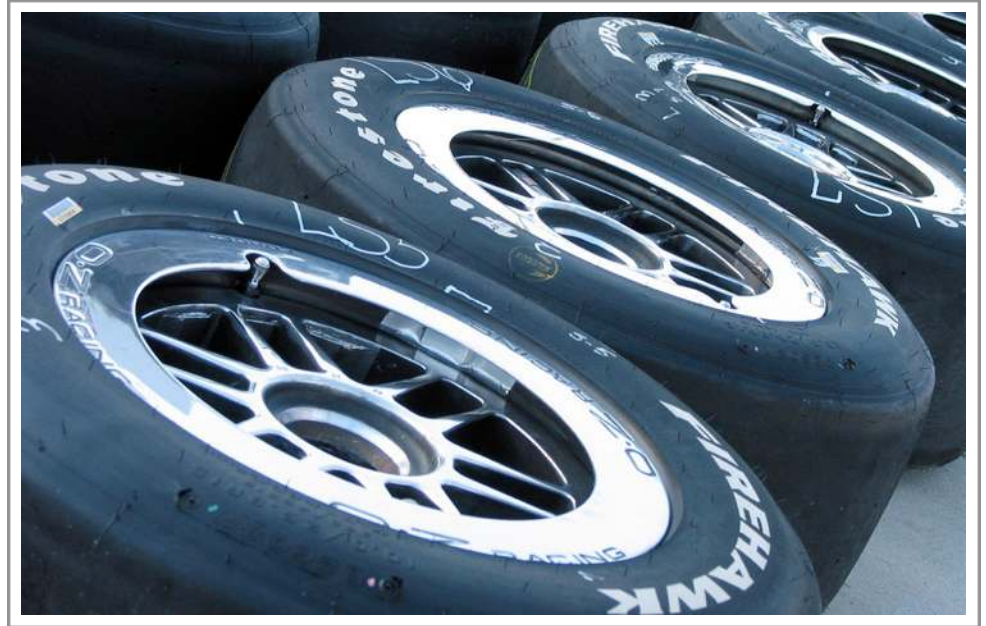
This Tire Industry client had an issue with the readability of the barcode label on their tires. The overall time the label spends in the oven ( from room temp to room temp ) is around 20 mins. The vulcanization process brings the tire to approximately 204C (400F).

The problem is barcode was getting damaged due to the heat, which also caused discoloration ( yellowing ). This made the barcode unreadable by the scanner.

Heat Shield™ High Heat coating was used over the polyester barcode label

for heat protection and to stop the yellowing.

The coating successfully protected the barcode from damage and discoloration and enabled proper scanning after the vulcanization process, solving a huge issue for the tire manufacturer.
