Case Study

Bandvulc Group- Tire Mold
Heat Exchanger.

Find a better solution for insulation of heat exchanger plates used on tire molds.

Heat Shield™ High Heat thermal insulation & corrosion prevention coating.

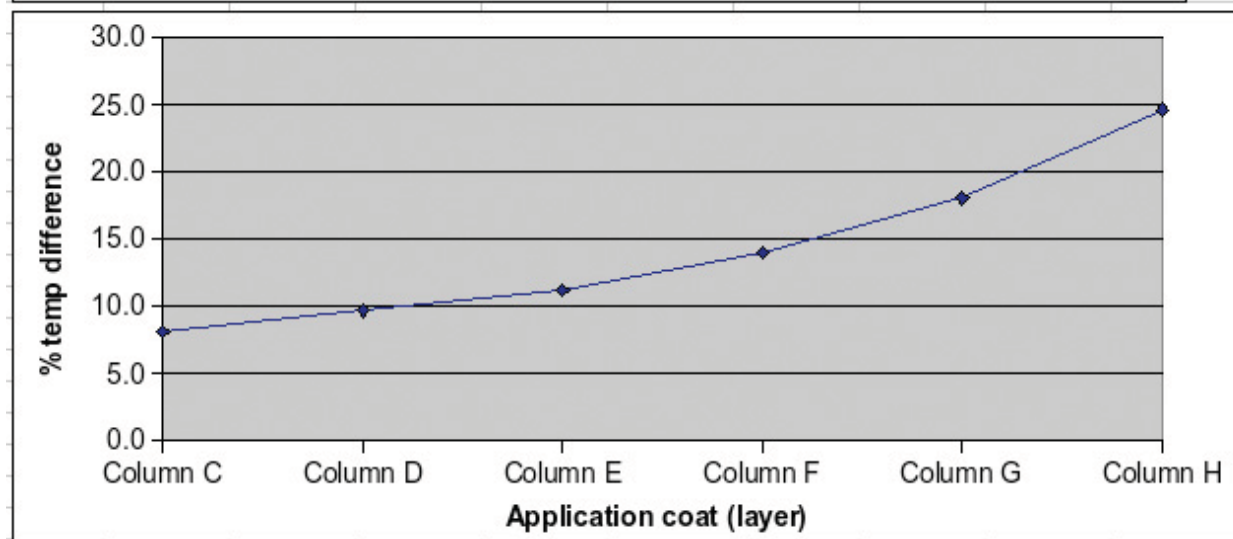
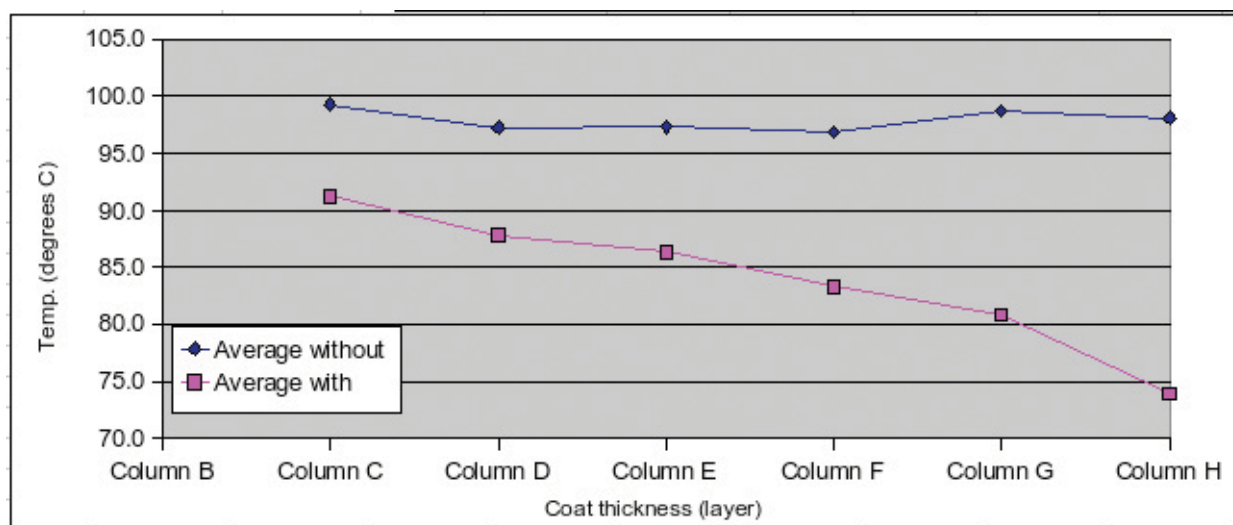
Exterior Heat Exchanger plate

Note: Study was done before all 8 coats had completely cured. Heat Shield™ reaches its full insulating ability after a full cure. Temperatures are shown in degrees Celsius.
