## CASE STUDY

## Sailboat

## Award Winning Energy Saving and Asset Protection Coatings

Looking to insulate a Bristol 29  
Sailboat

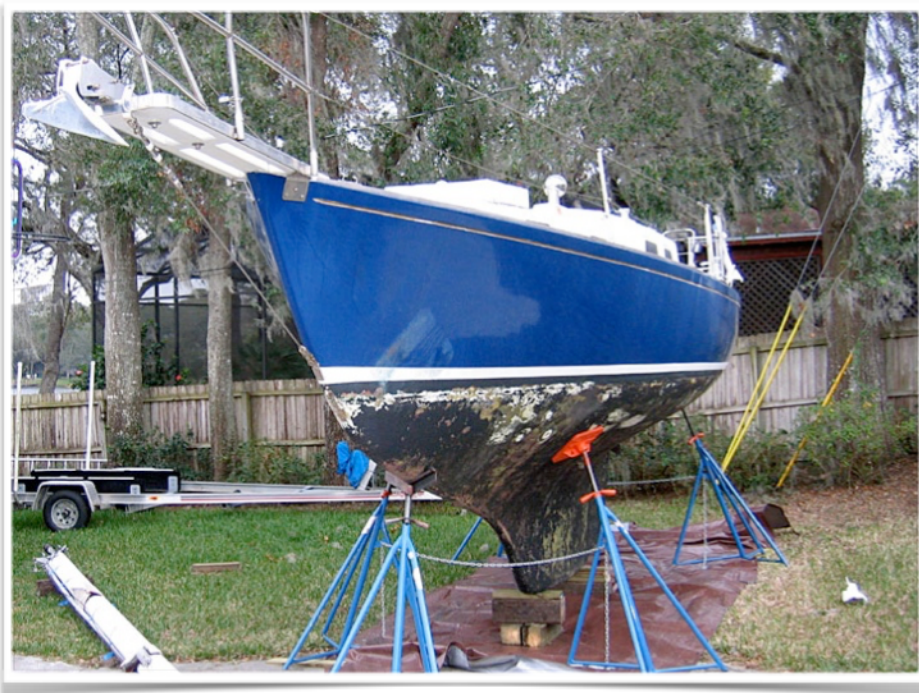
- ✓ Cabin Temperature Before: 105F
- ✓ Cabin Temperature After: 88F
- ✓ HomeProtect<sup>™</sup> Reduction: 16%  
Surface Temperature  
**Reduction: 13 to 15 degrees F**
- ✓ Clear coating allows the look  
of the surface to shine through

"I am using the product to insulate my 30' sailboat. I have applied three coats to the underside of the cabin and deck. Using a thermometer, the temp has been lowered from around 105 degrees F on a sunny Florida day where the ambient temps are in the high 80's to about 88 degrees F where the HomeProtect<sup>™</sup> is applied.

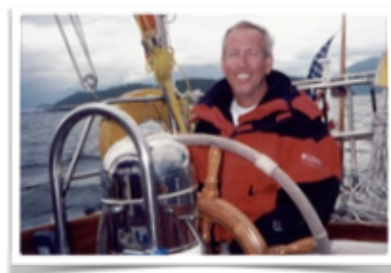
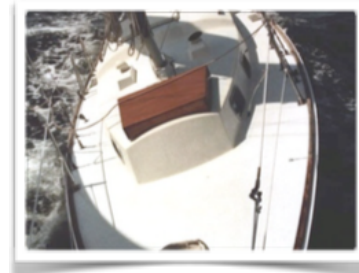
"I have seen around a 13 to 15 degree drop in surface temperature when I have applied 3 coats of HomeProtect<sup>™</sup>. I plan to apply more coats."
