Case Study

Petrochemical Manufacturer- Methanol Storage Tanks

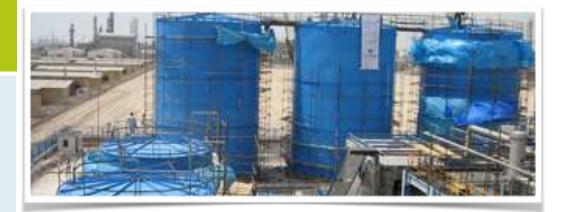
A petrochemical facility in the Middle East needed to significantly reduce vaporization of methanol inside storage tanks. Traditional insulation could not be used due to the high humidity in the region. Secondarily, they also wanted to prevent corrosion on the tanks.

Syneffex[™] Translucent High Heat insulation coating was used on the exterior of the tanks, with an overcoat of a blue tinted top coat in their desired color.

Syneffex[™] provided them with an effective thin film solution which was highly durable and effective in the demanding environment, stopped the vaporization and offered long-term protection. The tanks are checked every six months for corrosion, and none has been detected since installation of Syneffex[™] in summer of 2008.

During the warmest months, the ambient temperature gets as high as 55C (131F). When Methanol reaches temperatures in excess of 33C (91F), it begins to evaporate. Syneffex[™] eliminated the loss of product due to evaporation.
