# Sustainability Simplified.Tr Very Simple.

## CASE STUDY

**Residential Application**

**GEOGRAPHICAL AREA:** Dallas, Texas

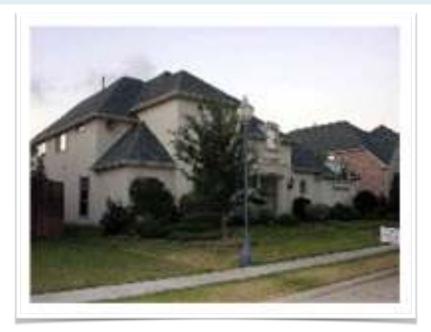
Healthy House Paint<sup>™</sup> by Syneffex<sup>™</sup> was used to coat the ceiling of the attic. The house was 4,000 square feet with an extremely high pitched roof line. The area of the attic was little over 3,000 square feet.

With the heat wave that had been experienced that year, the owner of the house put thermometers in the attic, monitoring the head through the day. During the later afternoons with the outside temperature at 104F, the inside of the attic was 143F!

The initial application covered 1/3 of the attic with 3 coats, and 2/3 of the attic with 2 coats. The crew returned two weeks later to apply the 3rd coat to the rest of the attic .

They noted the temperature outside was 103F (it was 3 hours earlier than the first application and at the peak of the heat for the attic). The temperature was 101F, a 42degree drop from the uncoated temperature.

The team continued coating the duct work, the A/C units (which are in the attic) and the ceiling of the attic. With the third coat over the remaining 2/3 of the attic now completed, the applications and owner expect and even better heat reduction results.

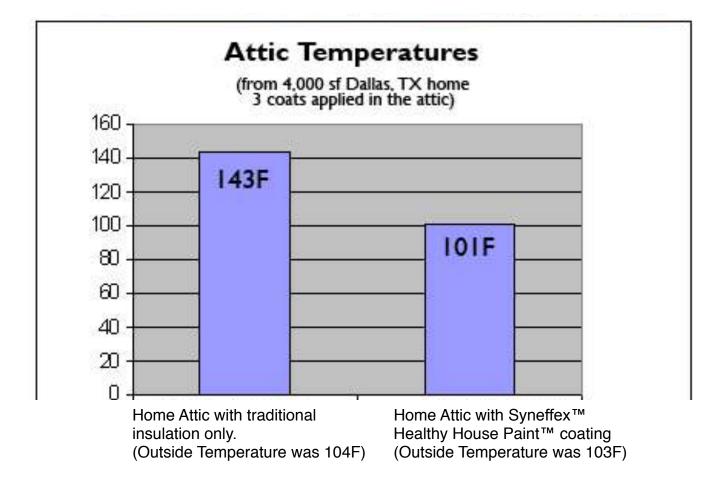
Reduction of approximately 42 degrees Fahrenheit with Syneffex<sup>™</sup> thermal insulating paint.
